TOWN OF BILLERICA, MA STORMWATER ASSET MANAGEMENT PLAN

April 2024

Tighe&Bond

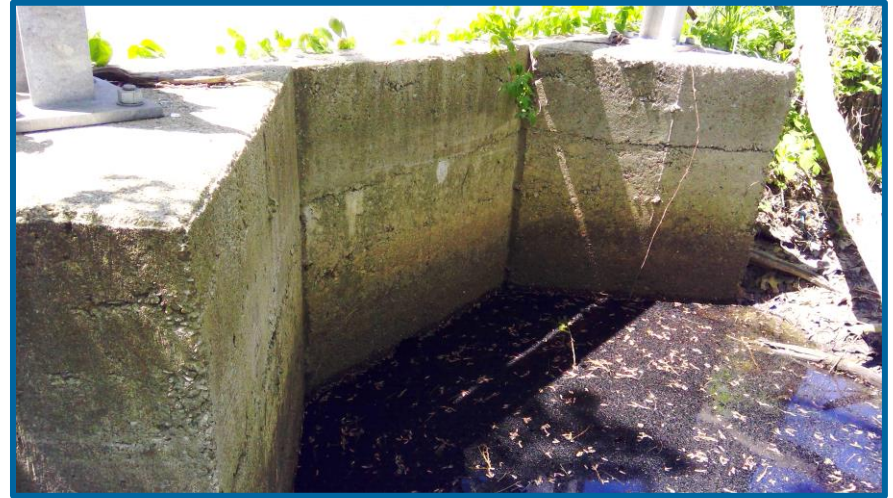
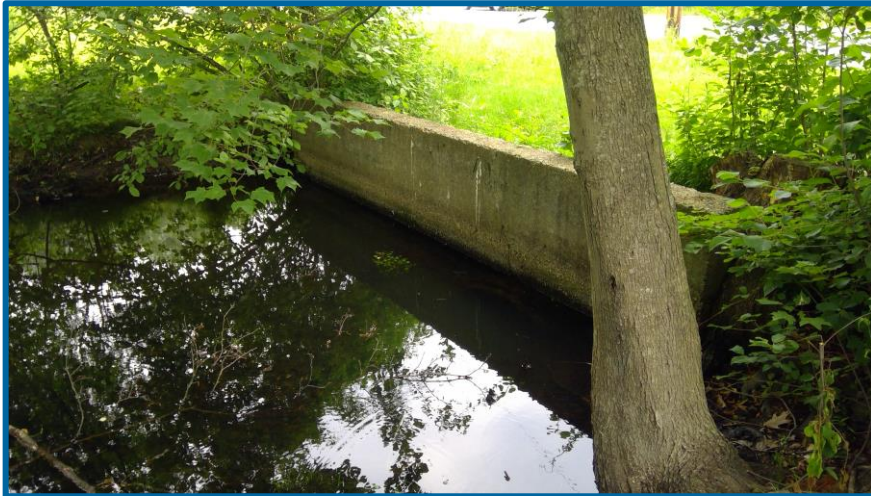
25 culverts were found to be submerged at the inlet and/or outlet of the culvert

Indicates there may be a hydraulic restriction within the stream reach and/or beaver dam impacts

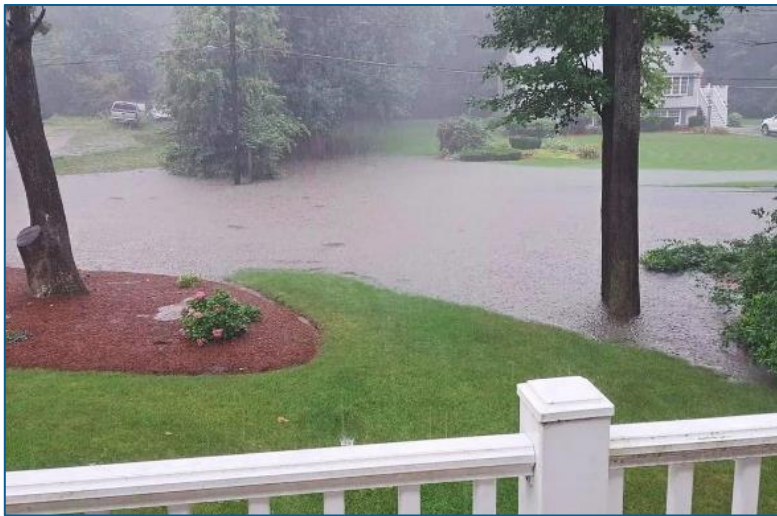
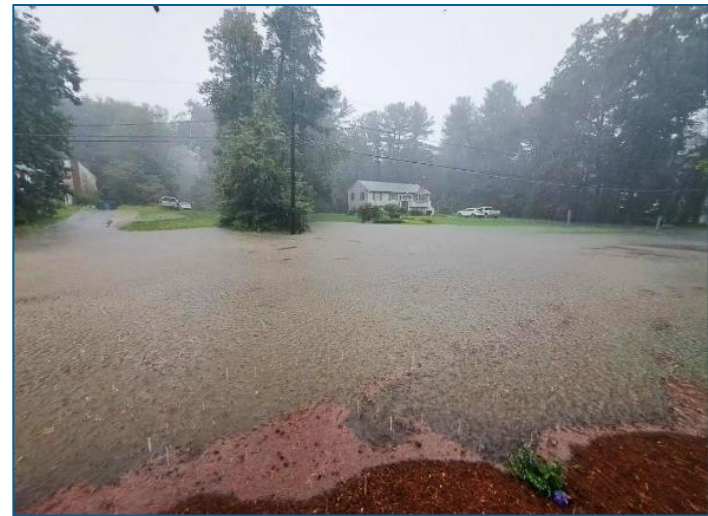
Severity of flooding on Shane Lane during a storm on August 8, 2023

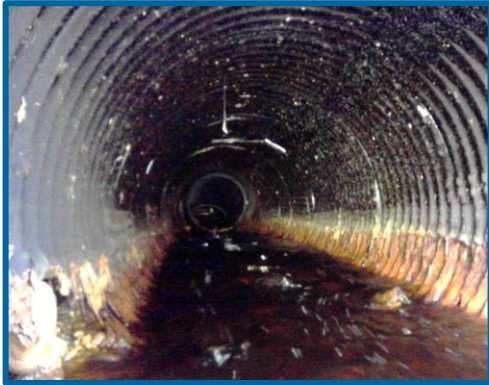
10 culverts changed material between inlet and outlet, which poses additional challenges to its structural integrity.

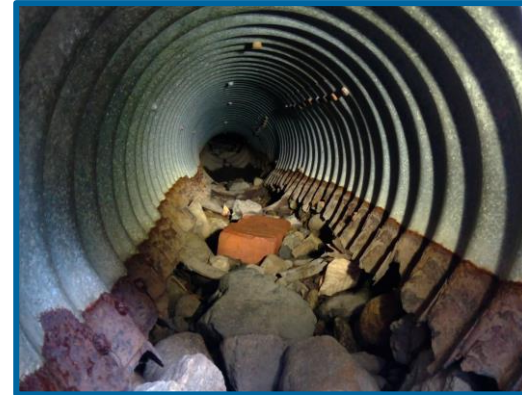
Corrugated metal pipes (CMP) are deteriorating. CMP made up 34% of the town's assessed culverts.

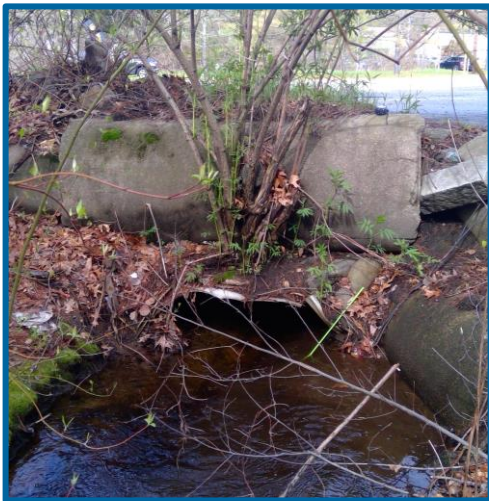
22 culverts had a tree present near the upstream and/or downstream headwall/wingwall. These may cause damage to the structure and should be removed as applicable.

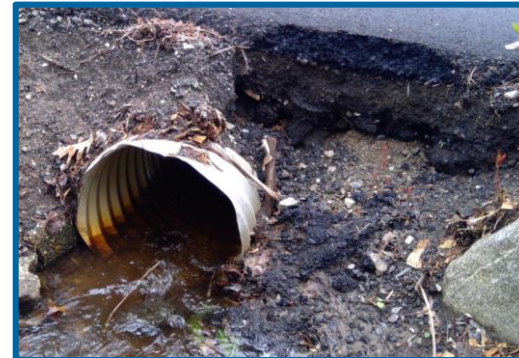
Poor or critical roadway embankment conditions were noted at 58 upstream locations and 47 downstream conditions.
